SPORT JET 90 INFORMATION UPDATE

1993-1994 Sport Jet 90

S/N 0E009675 thru 0E095087

The following represents the most common customer and/or dealer problems and solutions on 1993-1994 Sport Jets.

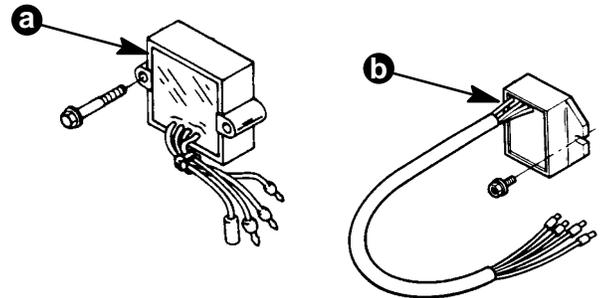
a - New Regulator
b - Old Regulator

The voltage regulator has been identified as the cause of stator failures. New, higher capacity voltage regulators, listed below, have resolved stator failures. Sport Jets with serial numbers above 0E066619 have the latest regulators.

Should a stator failure occur between serial numbers 0E009675 and 0E066619 replace the stator (p/n 8778A29) and the voltage regulator. The proper voltage regulator is listed below:

S/N 0E009675 thru 0E033710

Use regulator p/n 815279T 3
(Ring style terminals)

S/N 0E033711 thru 0E066619

Use regulator p/n 815279T 5
(Bullet connector style terminals)

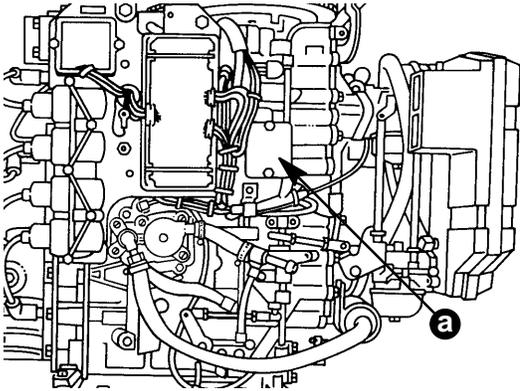
a - Rev Limiter

Faulty rev limiters can completely kill the ignition system, drop cylinders at a lower rpm, or allow engine to over rev. The rev limiter is designed to randomly drop cylinders so that the engine will not exceed 5800 rpm.

To isolate the rev limiter from the ignition system, disconnect the black/yellow lead from the rev limiter. Run the engine. If the problem is eliminated, the rev limiter is defective. The rev limiter p/n is 821889A18.

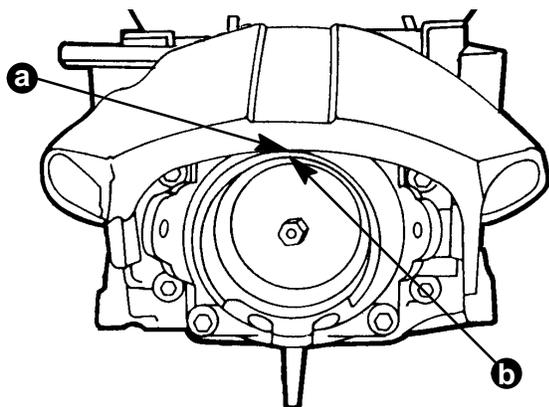
a - Reverse Gate Bottom Edge
b - Rudder Opening

There is some normal vibration from idle up to planing speeds. Severe vibration, at all speeds, was found to be the result of the reverse gate interfering with the rudder water flow. The reverse gate must be adjusted so that in full forward position, the reverse gate bottom edge (a) clears the rudder opening (b).

An improperly adjusted reverse gate will also result in loss of performance and/or a reverse gate forward stop failure. Refer to Service Manual 90-824724 for complete instructions on adjusting the reverse gate.

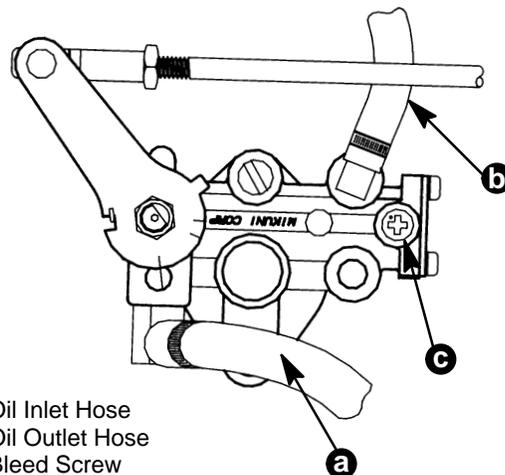
a - Oil Inlet Hose
b - Oil Outlet Hose
c - Bleed Screw

Powerhead failures can be caused by failure to bleed air from the oil lines. Check the oil line (a) from the reservoir to the oil pump. There should be no air in the line. If air is present, loosen bleed screw (c) and bleed air out until oil is present. Tighten bleed screw. The oil injection system is now operational.

Inspect the oil lines (a and b) for any kinks or sharp bends. Correct as necessary.

Check that all oil line connections are secured with sta-straps or clamps.
