## Supercharger System Troubleshooting – 135/150/175/200 Verado L4 and 200/225/250/275/300 Verado L6

This service bulletin is intended to guide the technician to properly diagnose Verado supercharger issues. It is also designed to eliminate the unnecessary replacement of a misdiagnosed supercharger, reduce the instances of no trouble found (NTF) supercharger warranty returns, and eliminate the subsequent warranty rejection of serviceable units.

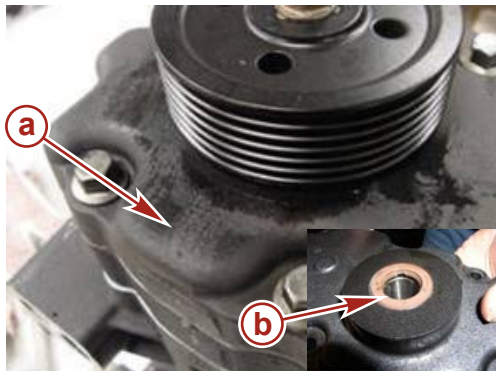
42667

1. Oil observed on top/front of supercharger.
  - **Situation**
    - Oil leakage observed at the top or front of the supercharger below the input pulley.

- Leak occurs during operation.
  - **Cause**
    - Supercharger input shaft oil seal leak.
    - Porosity or crack in the supercharger end cap.
    - Engine oil leak at the upper crankshaft seal.

- a - Oil present at top/front of supercharger
- b - Input shaft seal

- Run the engine for approximately 30 minutes and check for oil leaks.
  - **Correction**
    - Oil leak at supercharger input shaft seal.
      - Install supercharger end cap kit P/N 888947A10 (2005/2006 Verado), P/N 8M0045222 (GEN 1 and newer)

- Oil leak from porosity in supercharger end cap.
      - Install supercharger end cap kit P/N 888947A10 (2005/2006 Verado), P/N 8M0045222 (GEN 1 and newer)

- Engine oil leak at upper crankshaft seal.
  - Replace upper crankshaft seal.
  - If oil was present in the intake tube, the engine may have been past due for an oil change, the oil sump may have been overfull, or the oil separator in the cam cover may be faulty. Any of these conditions can cause oil carryover from the cam cover breather tube resulting in perceived supercharger oil leak. The supercharger should not be replaced under these conditions.

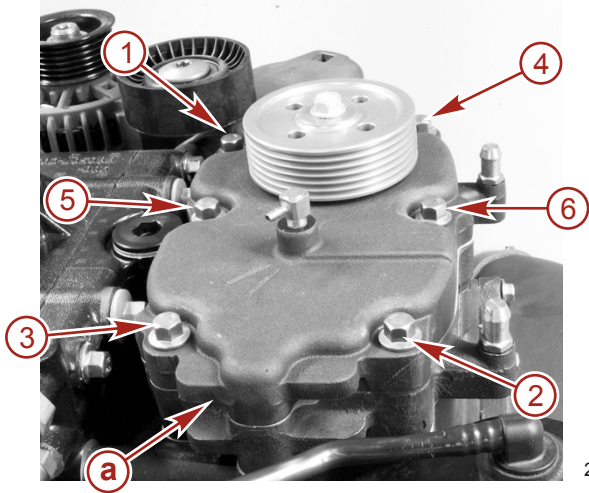
25689

**NOTE:** Number 1–6 denotes the proper torque sequence.

**a** - Supercharger bearing housing to end cap

- **Correction**
  - Oil leak at supercharger bearing housing to end cap joint.
    - Check the clamp load of the end cap bolts. Torque the end cap mounting bolts to specifications following the torque sequence.

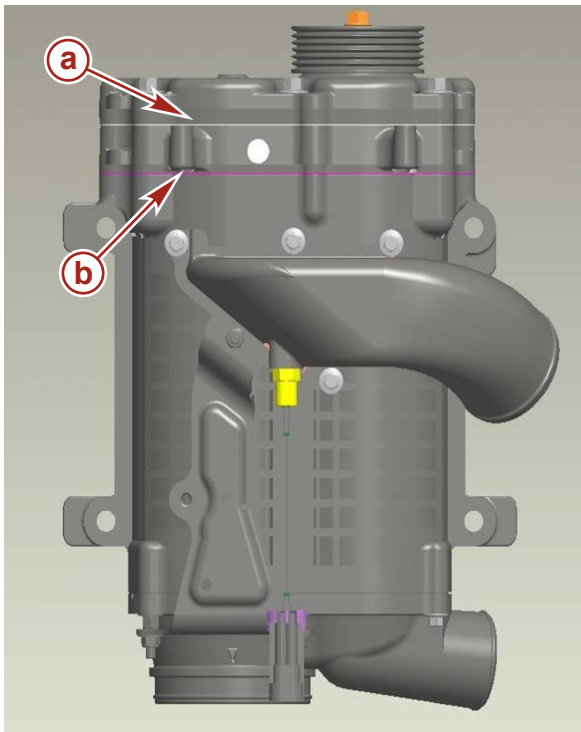
42668

- **Situation**
  - Oil leak observed at the supercharger bearing housing or end plate gasket joints.
  - Oil is observed on the supercharger rotor housing.

- Leak occurs during operation.
- **Cause**
  - Clamp load of supercharger end cap is low (loose bolts).
  - Excessive oil carryover from the cam cover breather hose.

**a** - Supercharger bearing housing to end cap joint  
**b** - Supercharger rotor housing to bearing housing joint

- Install supercharger bushing kit P/N 23-847803A02 (PEEK bushings and gasket).
  - Oil leak at supercharger rotor housing to bearing housing joint.

- Replace supercharger.
  - Oil leak from porosity in supercharger end cap.
    - Install supercharger end cap kit P/N 888947A10 (2005/2006 Verado), P/N 8M0045222 (GEN 1 and newer)

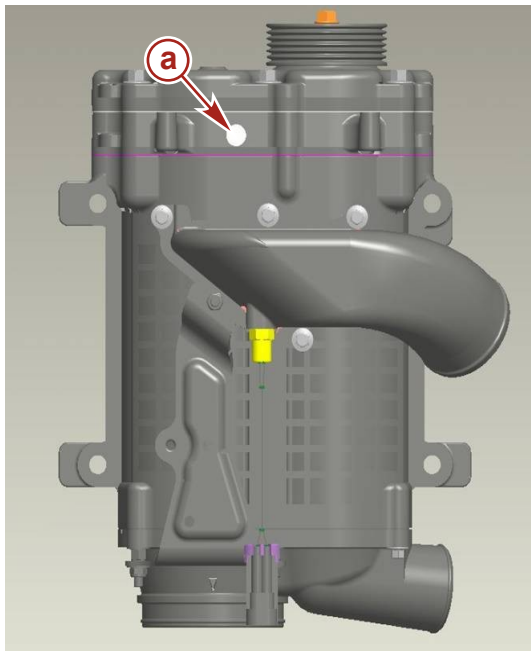
42669

- Oil leaking out of the front air vent filter of the supercharger.
- Oil is observed on the supercharger rotor housing.

- Leak occurs during operation.
- **Cause**
  - Rotor shaft oil seal leak.
  - Excessive oil carryover from the cam cover breather hose.
- **Troubleshooting**

a - Front air vent filter of supercharger

- **Correction**
  - Oil leak continues out of front air vent filter of supercharger.
    - Replace supercharger.
  - If oil was present in the intake tube, the engine may have been past due for an oil change, the oil sump may have been overfull, or the oil separator in the cam cover may be faulty. Any of these conditions can cause oil carryover from the cam cover breather tube resulting in perceived supercharger oil leak. The supercharger should not be replaced under these conditions.

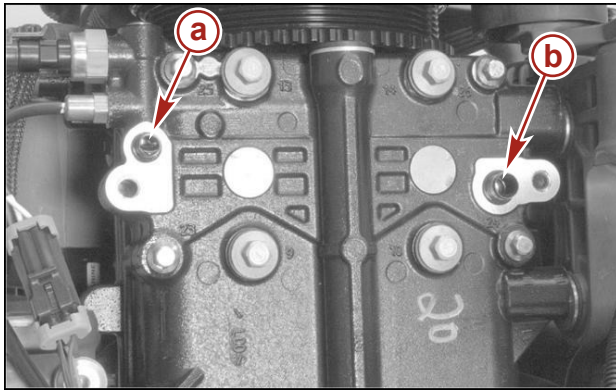
42670

4. Oil observed on rear of supercharger rotor housing.
- **Situation**
    - Oil leaking from the oil supply tubes between the engine crankcase and supercharger.
    - Oil is observed on rear of supercharger rotor housing and/or engine crankcase.
    - Leak occurs during operation or may form drips with the engine turned off.
  - **Cause**
    - Oil supply tube O-rings are missing or damaged.
    - Damaged supercharger mount feet, O-ring grooves, or damaged supply tube fittings.
  - **Troubleshooting**
    - Clean the oil from the supercharger and engine using a degreaser.
    - Run the engine for approximately 30 minutes and check for oil leaks.

- a** - Oil delivery O-ring and dowel pin (11 mm)
- b** - Oil return O-ring and dowel pin (14 mm)

- Oil leaking from the oil supply tubes between the engine crankcase and supercharger.
  - Remove supercharger, inspect supply tubes, and O-rings. Replace O-rings and supply tubes as needed.
  - Inspect supercharger mount feet and O-ring grooves for damage. Replace supercharger as required.

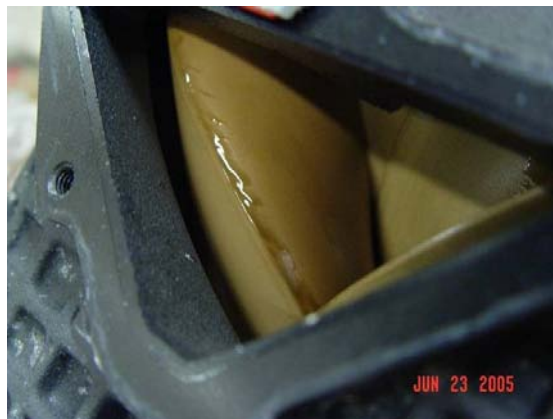
42671

- Oil observed on supercharger rotors and in outlet duct to charge air cooler (CAC). Supercharger outlet duct housing removed.
- Engine burns oil.
- Engine smokes at start-up.

- Excessive oil carryover from the cam cover breather hose.
- Bearing housing oil seal damage or leak.
- Excessive crankcase pressure stops oil drain back from supercharger.

- If oil is observed upstream of the supercharger (intake resonator, inlet boot, or inlet duct), the problem is excessive oil carryover from the cam cover breather. The supercharger should not be replaced under these conditions.
- If no oil is observed upstream of the supercharger, remove the supercharger outlet duct and inspect for oil coverage on the rotors and outlet duct to the charge air cooler. If oil is present, replace the supercharger.

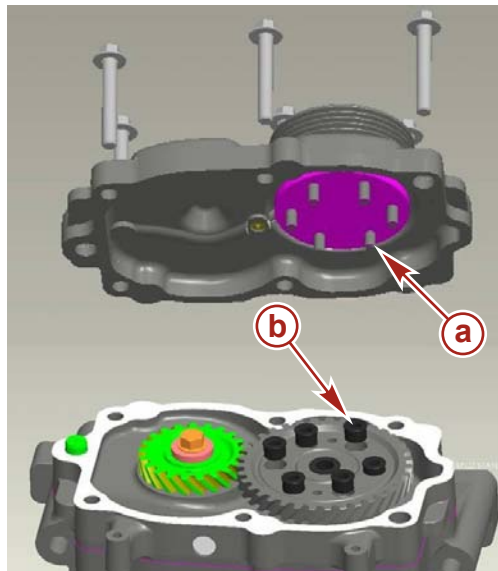
42672

- Noise or rattle between 1000–1300 RPM.
- Noise goes away with the accessory drive belt removed.

- Worn bushings resulting in clearance between input drive pins and supercharger driven gear.

- a - Input shaft pins
- b - Bushing

- Noise is only audible with the cowl off or is difficult to hear with the cowl on.
  - This condition is normal and is not detrimental to the supercharger or engine.
  - No correction is needed.
- Noise is easily audible with the cowl on.

- 2005 Verado L6: Use supercharger end cap kit P/N 888947A10 which includes updated PEEK bushings. Refer to Outboard Service Bulletin 2007-05.
- 2006 and newer Verado L4 and L6: Use supercharger bushing kit P/N 23-847803A02 (PEEK bushings with gasket).

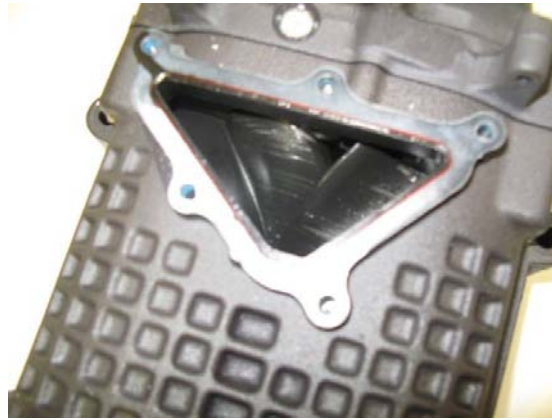
42673

- Noise that can be heard at all RPMs with the cowl on.
- Noise level increases with RPM.

- Possible rotor to rotor contact.
- With the engine off, remove the accessory drive belt. Turn the supercharger pulley using a socket on a torque wrench. Tight spots of 10 Nm (88.5 lb-in.) or more indicate a problem.

- Low hour engines (less than 10 hours of operation) may emit noise due to a slight rotor to rotor coating contact. This condition may wear or break-in and is not detrimental to the supercharger. Monitor the noise level for the first five hours of operation.
- Possible internal gear problems.
- Possible bearing problems.

- Input shaft pins or bushings broken or missing.
- **Correction**
  - Noise level that remains constant or increases over the first 5–10 hours of engine operation indicates that the supercharger should be replaced.
  - Noise level that diminishes after the first 5–10 hours of engine operation indicates supercharger rotor coating break-in. The supercharger should not be replaced under these conditions.
