Front Engine Mount Deflection

All Gas Sterndrives

Date: 04-1998

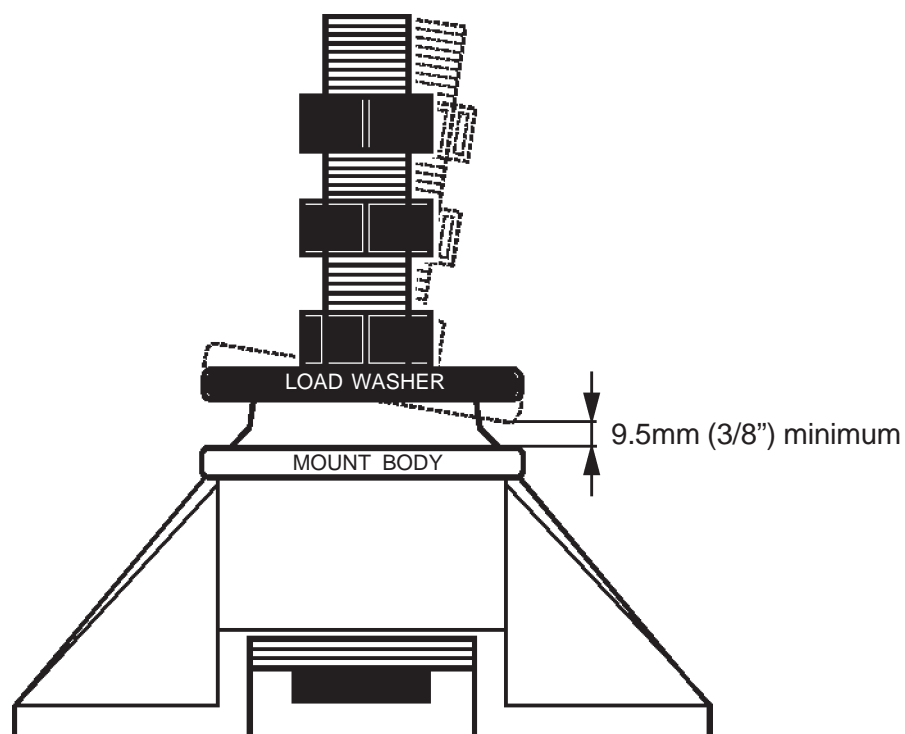
Volvo Penta has received reports that front engine mounts have been installed incorrectly. Incorrect installation can cause the engine mounts or engine block to crack.

The engine package is designed so that, on a boat with a 13° transom angle and the stringers installed parallel to the boat bottom, the front engine mounts will have zero (0) deflection. This means that the gap between the load washer and the mount body will be of equal distance on all sides. The mount is allowed an amount of deflection to compensate for different transom angles and the stringer installation. With the maximum deviation allowed, the minimum distance between the load washer and the mount body is 9.5mm (3/8"). If the clearance does not fall within the minimum distance, you must modify the stringers or install angled shims (spacers) between the stringers and the front mounts. Shims should be made of a material (e.g., aluminum) that will not rot, shrink, crack, break, or in any other way change its size or shape.

Install the front engine mount **perpendicular** to a boat's stringers or mounting pads so that the front engine mounts can absorb and defer engine vibrations properly. Make sure that the clearance (gap) between the load washer and the body of the mount is even on all sides. There is a slight tolerance in this gap to compensate for transom angle and stringer installation. The boat's transom angle should be between 10° and 16° (13° is preferred). The stringer system should be installed **parallel** to the boat bottom (refer to the installation instructions supplied with the engine package).
