VOLVO PENTA

Service Bulletin

Power Steering Hoses

4.3L, 5.0L & 5.7L

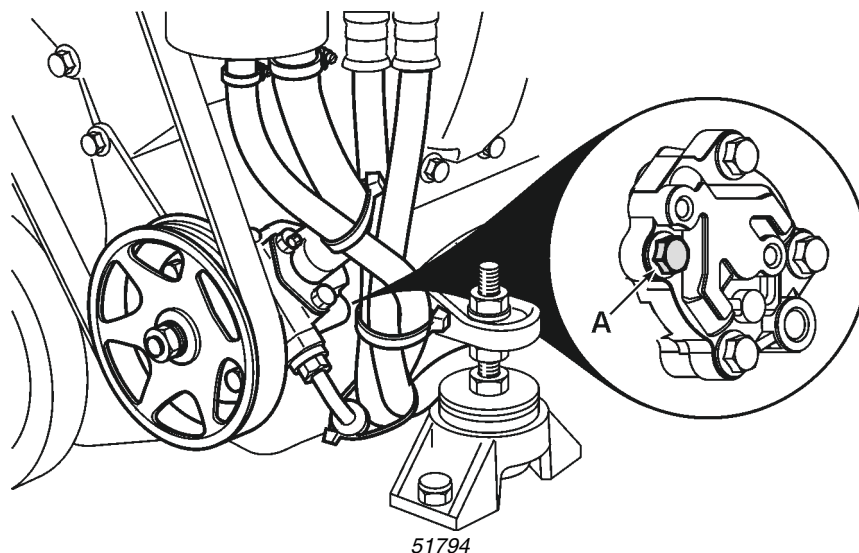
Volvo Penta has discovered that on some engines the power steering oil hoses rub against the bolt **A** on the back of the power steering pump, resulting in wear and ruptured hoses. Prior to delivery or during the next scheduled service, please be sure to check the positioning of all hoses that pass close to the back of the power steering pump and, if necessary, make the adjustments described below.
