Exhaust flapper valve

3.0, 4.3, 5.0, 5.7, 7.4, 8.2 Gas Sterndrive Engines

Date: 9-1999

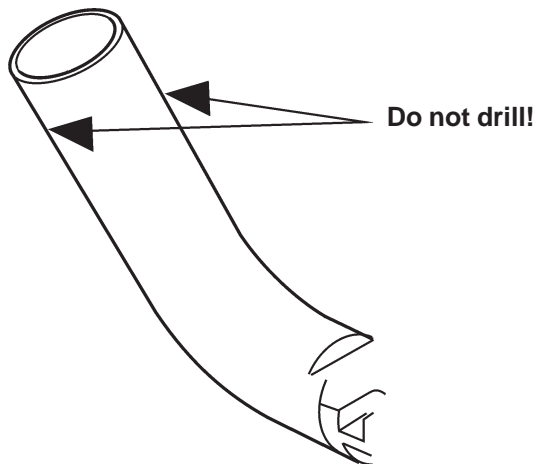
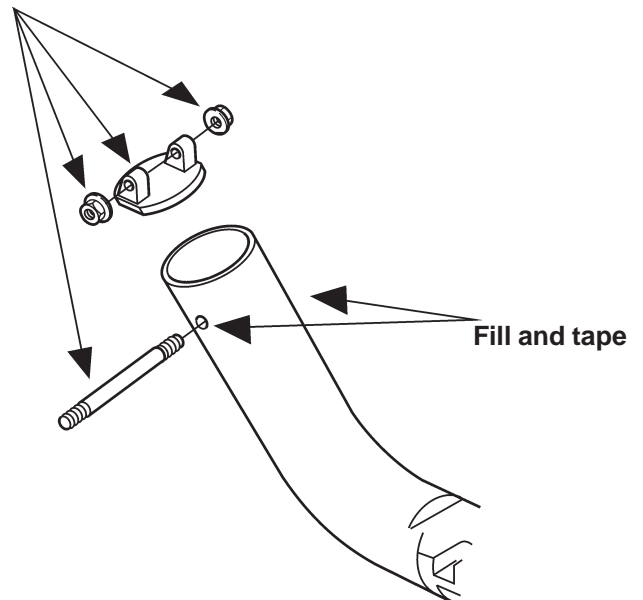
After extensive testing Volvo Penta has found that the exhaust flapper valve located in the exhaust pipe is not effective in preventing water ingestion. The valve has a short lifespan and has been known to disconnect from its pivot rod and clog the exhaust system. Therefore, Volvo Penta will no longer include an exhaust flapper valve on the engines listed above.

Remove and discard

4. Fill the holes with silicone.
5. Cover the holes with masking tape.

1. Do not reinstall the valve.
2. Remove and discard the valve, pin, and bushing.
3. On the exhaust pipe, clean out any residue from the holes.

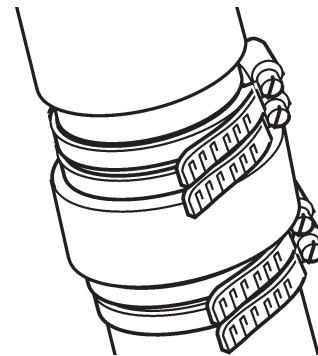
6. Reinstall the exhaust bellows. Make sure the bellows cover the masked holes.

If you do not follow the steps below, and do not adequately cover the holes in the exhaust pipe, water will leak in to the boat bilge. If the leak is left unnoticed, the boat could sink.
